LINCOLN SCHOOL REPAIR ANALYSIS REPORT

*A Report to: Town of Lincoln
October 15, 2012*

Prepared by: CDR Maguire Inc.
211 Congress Street, 11th Floor
Boston, MA 02110

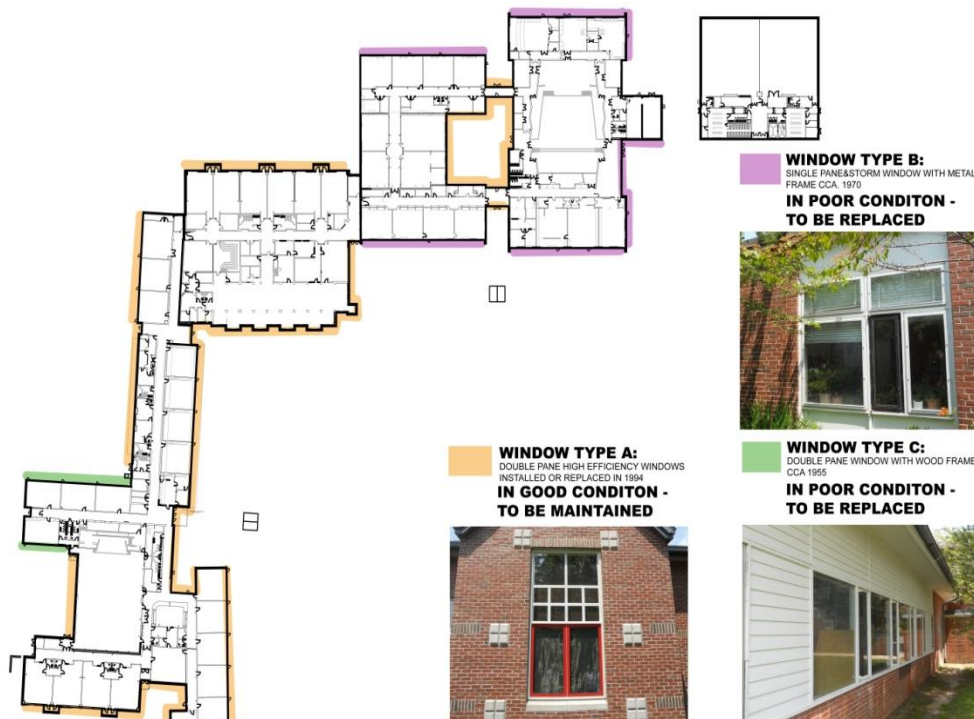
The exterior windows of the facility vary within the vintage of the building. Consequently, the windows in the portion of the facility renovated in 1994 have insulated glass and are in good condition. This includes the majority of the Smith School and the Link Building. The windows in the 1963 addition to the Smith School are also insulated glass, however, the windows and the associated wood trim are in poor condition and are in need of replacement.

The windows in the Brooks School are the original 1970's vintage. As per the construction standards of the time the windows are not insulated and set in a non-thermally broken metal frame.

The replacement of the existing un-insulated windows is not mandated by any code or regulations; it is an occupancy comfort/energy efficiency issue for the building. It is anticipated that the replacement of single pane glazing to insulated glazing will pay for itself within 15 years. The replacement of the Brooks windows will also require the abatement of the existing transite panels.

In addition to replacing the windows, all of the deteriorated and damaged wood trim should also be replaced.
